Manhole Inspection Summary

Manhole # S21II_022MH

Insp Date: **6/21/07 2:20 PM**

Location Address: **1701 MONROE-APPLETON**

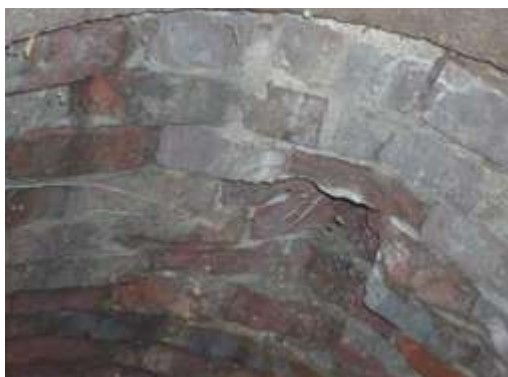
Defect 2

Condition: ☐ Sound ☐ Cracked ☒ **Root Intrusion** ☐ Loose Brick ☒ **Deteriorated**

DETERIORATION OF CORBEL AND
ROOT INTRUSION

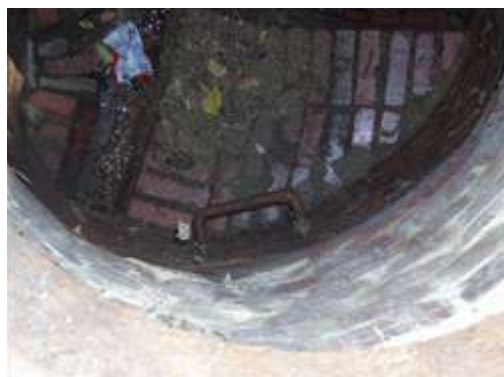
Defect 1

Count: **1** Missing: **2** ☒ **Corroded**

CORRODED STEP AND MISSING

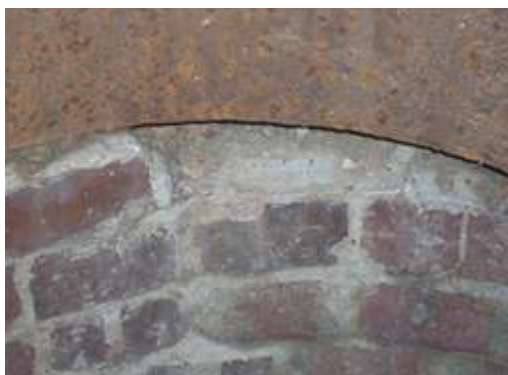
Defect 3

CORBEL DETERIORATION

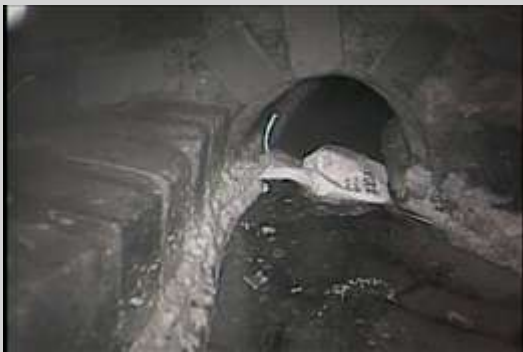
12 O'Clock Outflow

Pipe Height: **8.4** (in.) Rod and Bar (Angled)
Pipe Material: **Clay** ☐ Pipe Lined
Invert Depth: **7.98** (ft.) Flow Characteristics: **Slow**
Deposits: ☐ None ☐ Mud ☐ Sludge ☒ **Debris** ☐ Grease
Silt Depth: **3** (in.) Deposits Extent: **Medium**
Infiltration: **None** Pipe Seal Cond: **Sound**
